Situation Photo Log

Tuesday, May 15, 2012

Kalamazoo River / Enbridge Spill

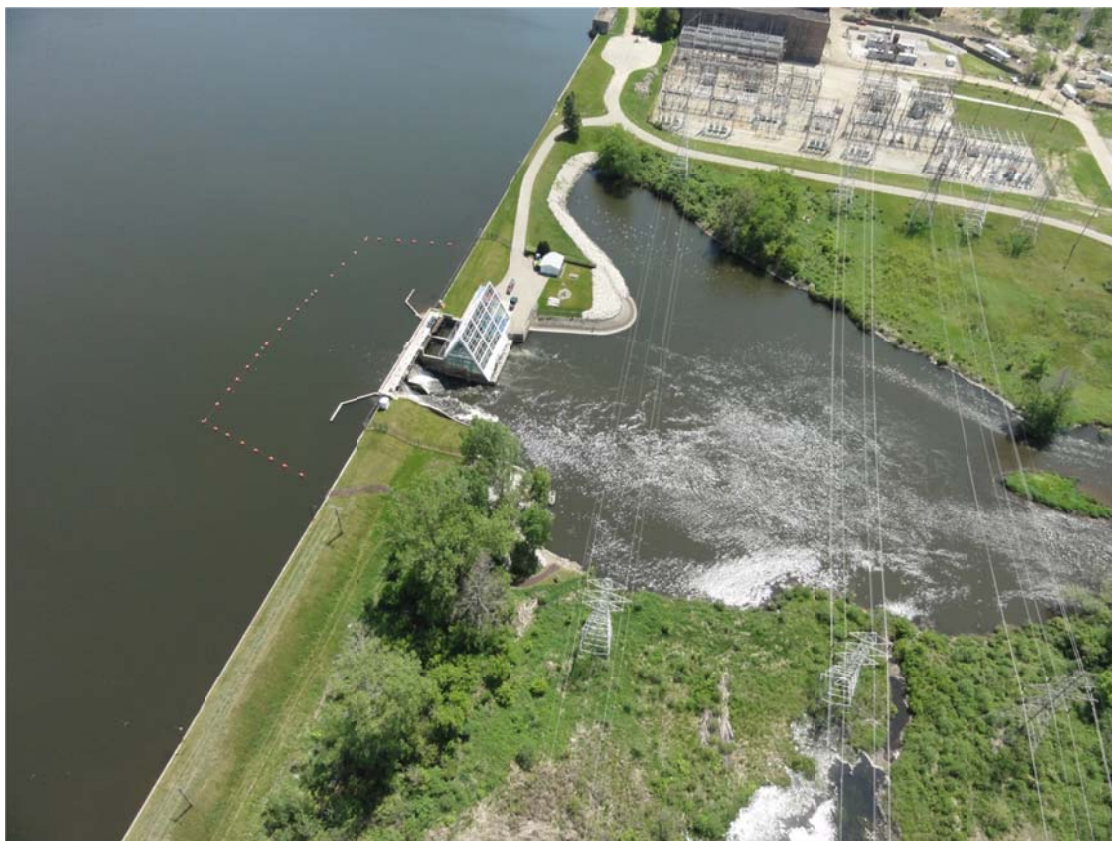
24. Morrow Lake Dam, no sheen observed.

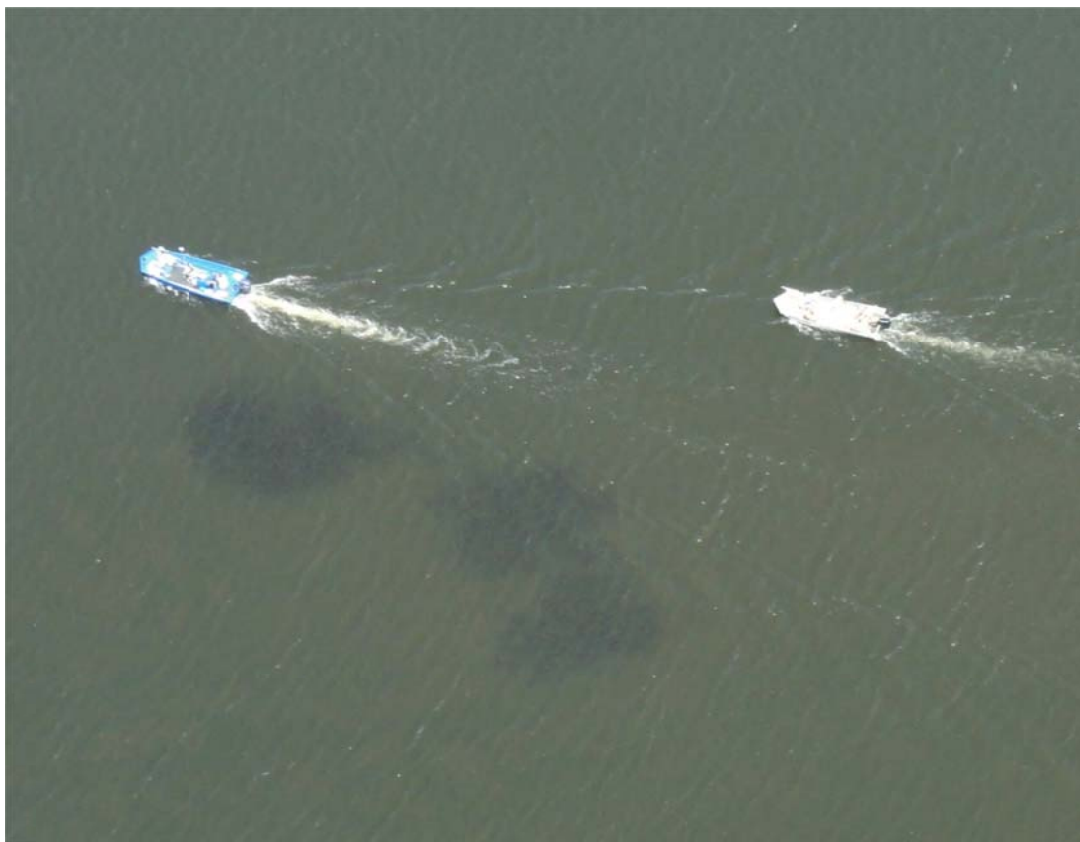
25. Poling crew observed in southwestern corner of Morrow Lake.

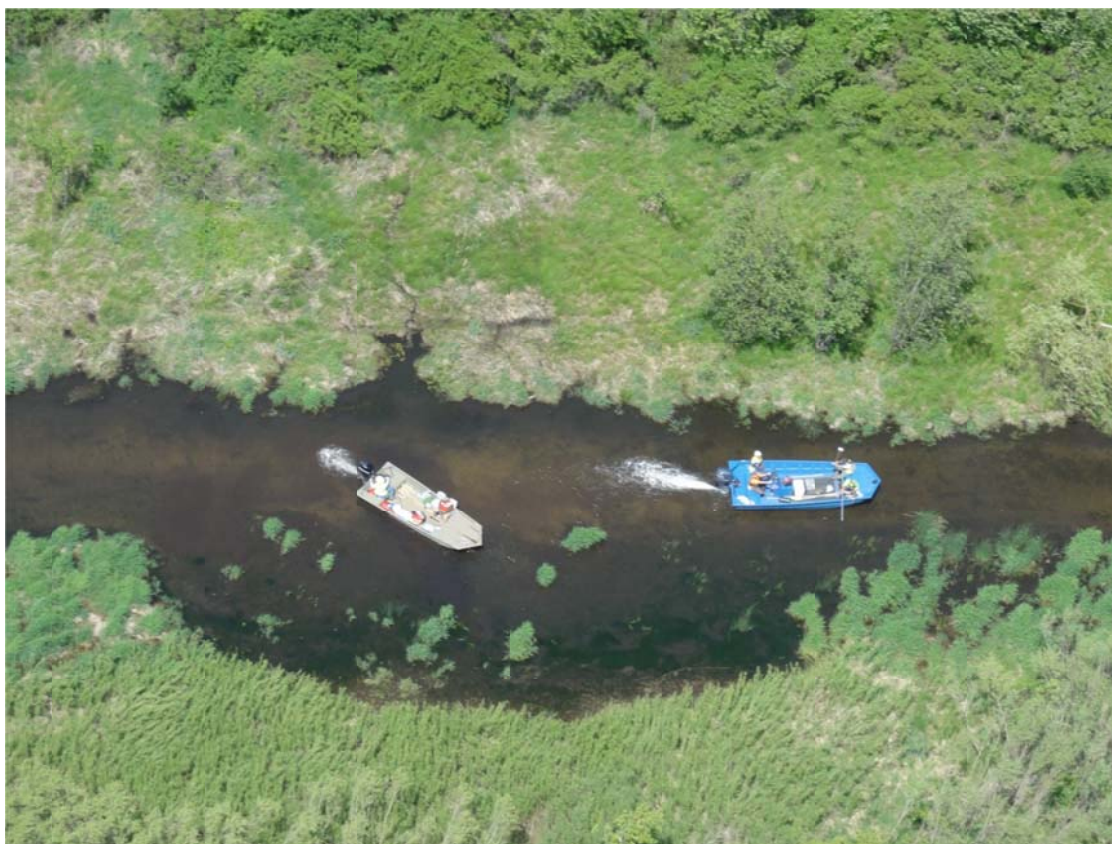
26. Poling crews moved to backwater channel near MP4.0 RDB.
